Manhole Inspection Summary

Manhole # S69S__001MH

Record Plat: **69S** Node: **001** Status: **Found**

Location Address: **6600 Hartwait St.**

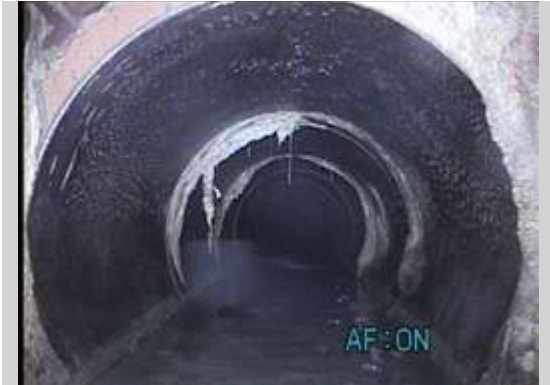
12 O'Clock Outflow

27 in. Circular Gravity Sewer
Pipe Out @ 12 O'Clock

Pipe Height: **27.6** (in.) Rod and Bar (Angled)
Pipe Material: **Clay** ☐ Pipe Lined
Invert Depth: **16.42** (ft.) Flow Characteristics: **Fast**
Deposits: ☒ None ☐ Mud ☐ Sludge ☐ Debris ☐ Grease
Silt Depth: (in.) Deposits Extent:
Infiltration: **None** Pipe Seal Cond: **Sound**

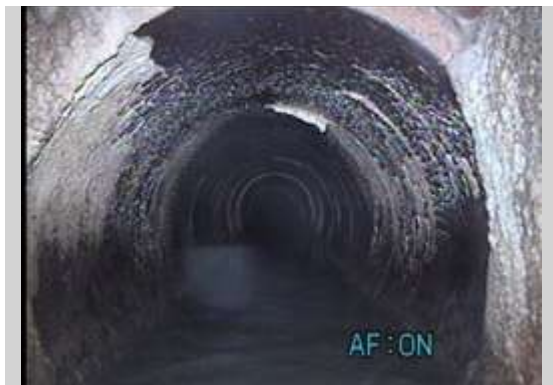
6 O'Clock Inflow

27 in. Circular Gravity Sewer
Pipe In @ 6 O'Clock

Pipe Height: **27.6** (in.) Rod and Bar (Angled)

Infiltration: **None** Pipe Seal Cond: **Sound**
